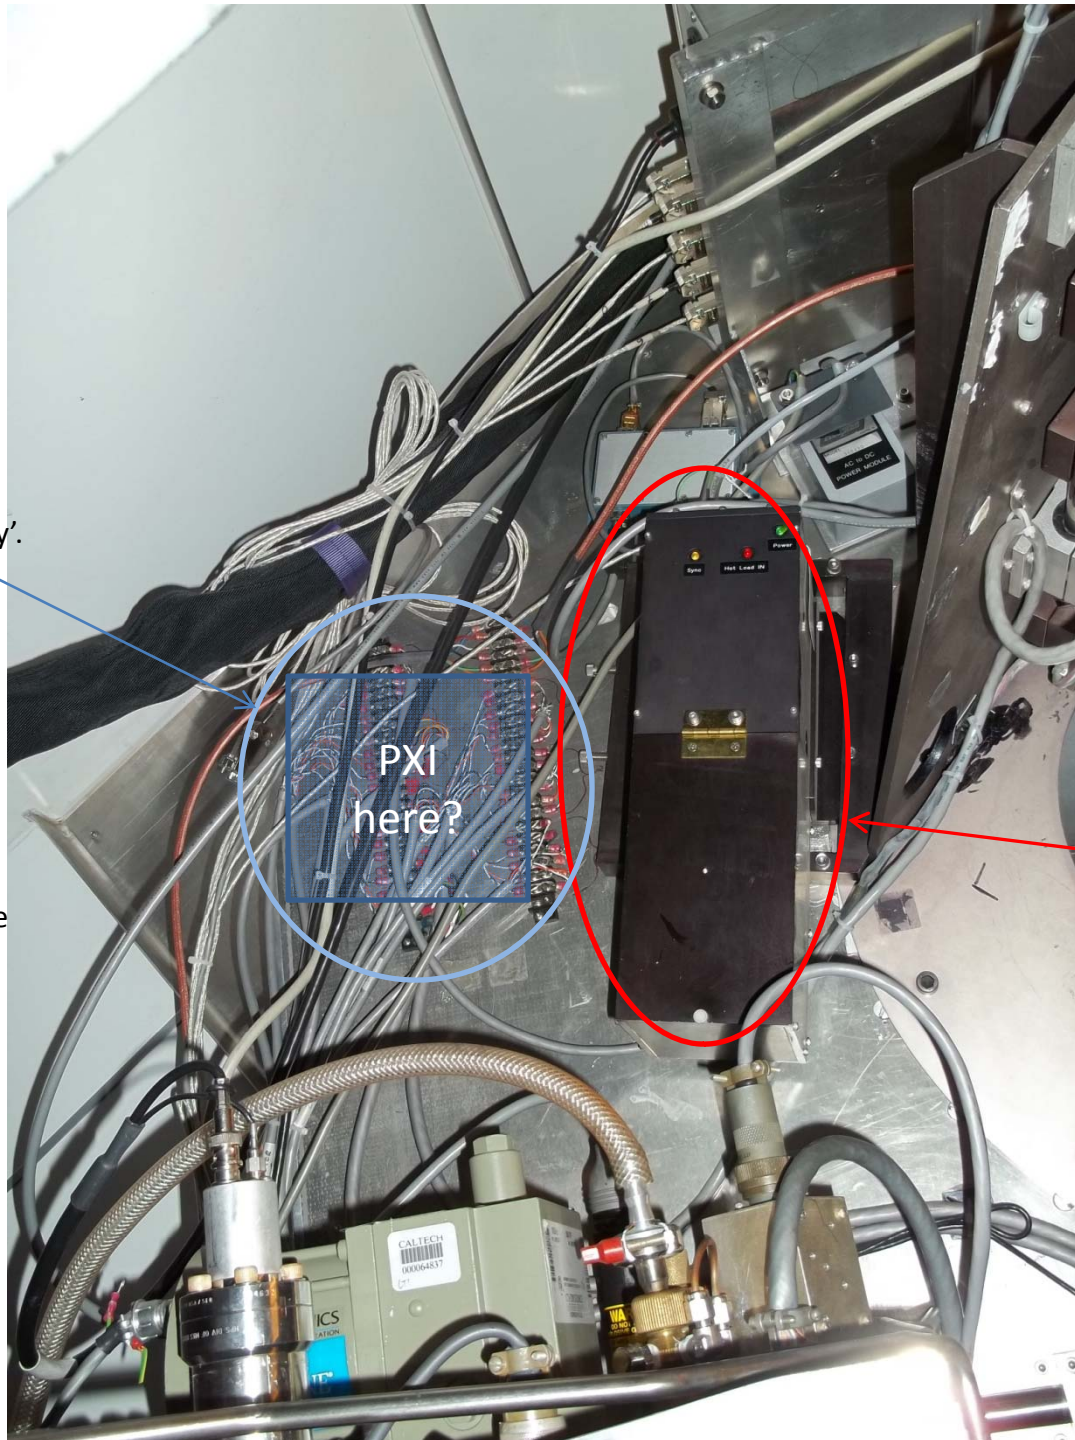
This has always
been there from
The beginning of time
or since 'Budha was a baby'.
(< 1990)

It can be moved. It has
Nothing to do with the Rx.
Maybe it is the mirror
Motor control or
focus control
(stepper motors).

We can clean this when the
Dewar is pulled off I
Imagine.

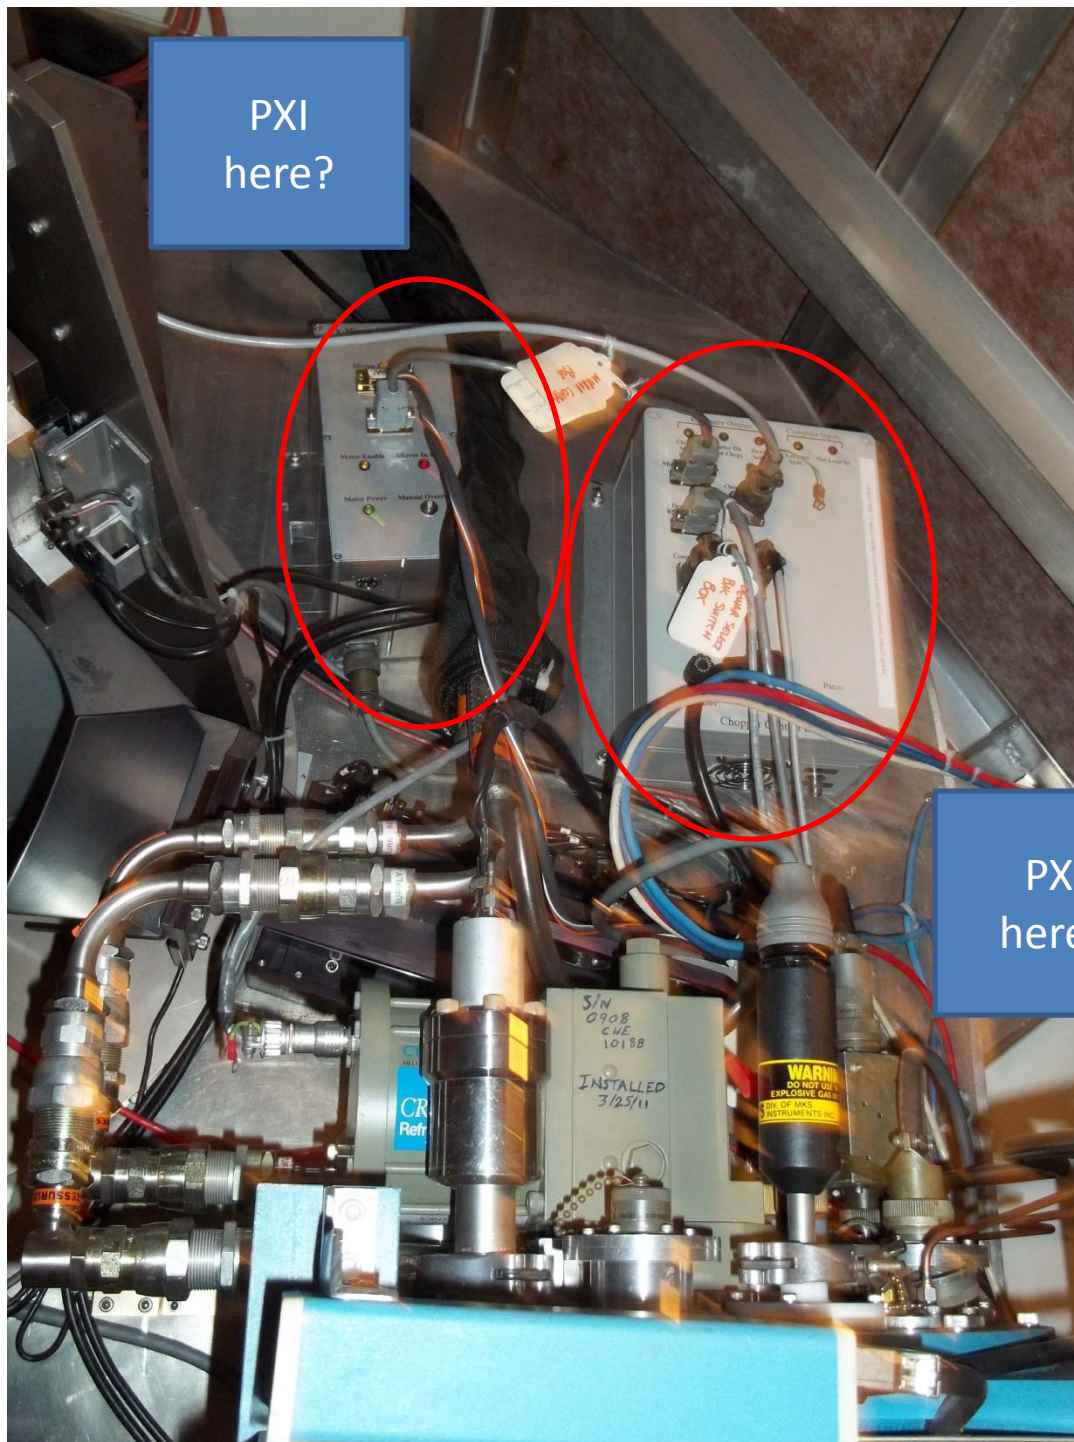
Old Cold load.
Defunct. But the
Octagon software
Needs it to operate
I think. → Space will
be freed up once
The new Rx come out.

Both are control boxes used by the Octagon software. Will be removed once the dewars are replaced. I think the Octagon software expect them. e.g. freezes w/o these boxes.

This shows one of the problems of having two completely different Systems (Octagon vs PXI and Gunn vs Synthesized LO). Better to swap everything out at once if at all possible.

So yes, once again the Lhe fill clearance problem. Keep in Mind the PXI crate connectors (2-3") will stick out and are very vulnerable. maybe mount the PXI crate off to the side?

You can try disconnecting
the DB-9 connector and
See if the octagon
Handheld boots up/freezes.
